Inspection Report

Inspection Date January 8, 2018
Client [REDACTED]
Inspector Bruce Ogletree
712 N. Lucas
Grapevine, Texas 76051
www.ogletreehi.com
214-287-4630
ogletreehi@gmail.com

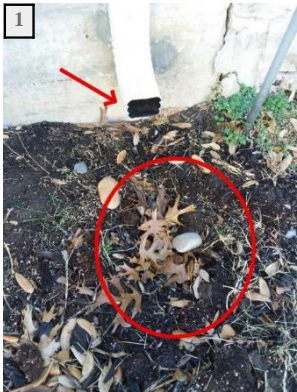
1.		
	Item	Downspout
	Concern	Downspout drains at foundation due to leaking, detached, or missing lateral section and/or splash blocks
	Location	Exterior: Ground View
	Impact	May cause erosion and/or excessive moisture collection at foundation
	Suggested Action	Direct water away from foundation with appropriate and properly connected fittings, and protect soil from erosion with properly positioned lateral section and/or splash block.

Noted at North East
and South East corners

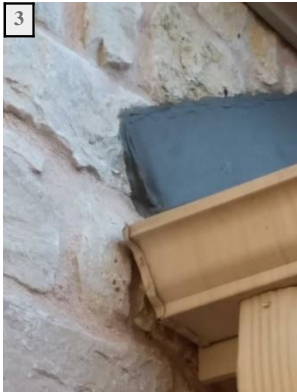
Item	Roof Flashing
Concern	Lacks kick-out flashing
Location	Exterior: Roof View
Impact	May not properly direct drainage, allow damage or discoloration to siding materials
Suggested Action	Have corrected by a qualified roofer
Other Information	Kick-out flashing is normally installed where the edge of the roof meets a wall, and is meant to direct water away from that wall, minimizing leaks and other problems.

On North side

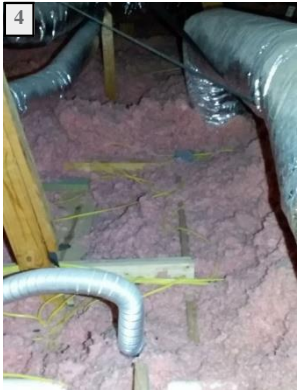
Item	Insulation
Concern	Insulation absent or damaged in a few places
Location	Attic
Impact	May affect energy efficiency
Suggested Action	Consider adding insulation

Behind northernmost air handler in attic

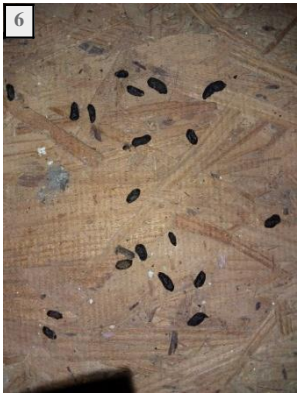
Item	Floor
Concern	Evidence of rodent/other pest infestation in attic.
Location	Attic
Impact	May create unsanitary conditions
Suggested Action	Seal off points of entry and have treated by licensed exterminator

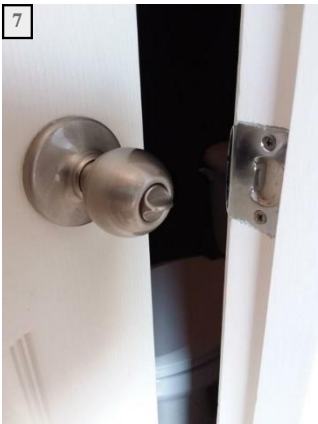
Item	Interior Door
Concern	Lock button is on wrong side of door
Location	Master Bathroom, Upstairs Den
Impact	May result in person be coming trapped on other side of door
Suggested Action	Remove and reinstall knob so persons in enclosed areas can access the lock button, unlock the door, and exit the area.

Master bathroom water closet door

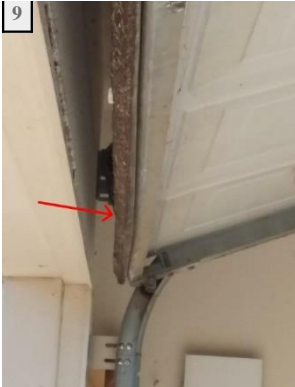
Item	Overhead Door
Concern	Minor damage
Location	Attached Garage
Impact	While still functional, hardware may be compromised
Suggested Action	Consider replacement if desired

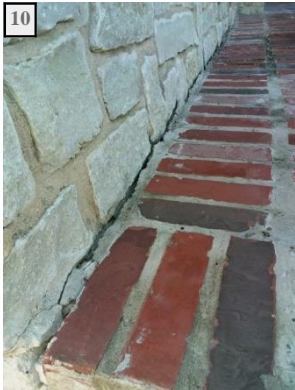
Item	Front Porch
Concern	Gaps between porch and exterior wall
Location	Exterior: Ground View
Impact	Possible intrusion point for pests and moisture
Suggested Action	Add mortar or sealant or close gaps

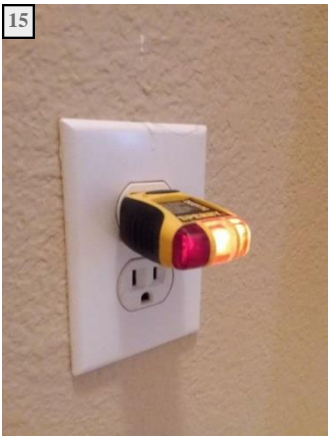
Item	Outlet
Concern	Does not provide GFCI protection
Location	Exterior: Ground View, Laundry Room/Mudroom
Impact	Shock hazard
Suggested Action	Have licensed electrician install GFCI protection devices at the outlet or at the breaker panel.
Other Information	Does not trip when tested. GFCI protection is required within 6 feet of all basins, potential wet locations, at all kitchen counters, in garage, and all outdoor locations.

Laundry room

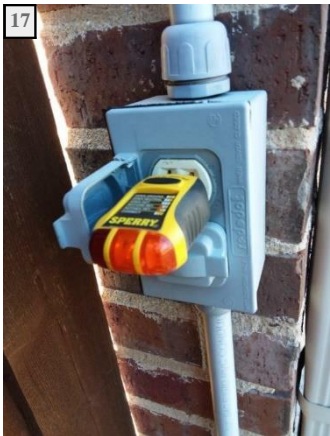
At South East corner of
garage

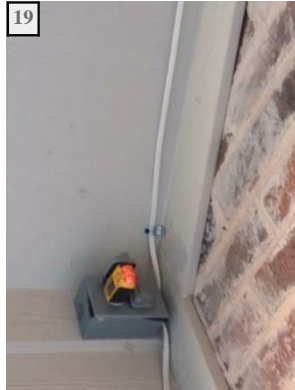
Item	Wiring
Concern	Wiring not protected by conduit
Location	Exterior: Ground View
Impact	Insulation may weather or become damaged by pests, exposing conductors, creating a shock hazard
Suggested Action	Have repaired by a licensed electrician

At back porch and under soffit on east side of garage

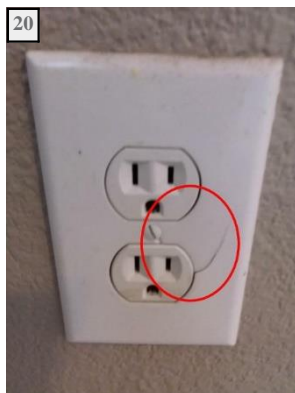
Item	Outlet
Concern	Cover is cracked
Location	Middle North Bedroom
Impact	Crack could spread, causing breakage and exposure of wiring with resulting shock and fire hazard
Suggested Action	Replace the cover

Middle North bedroom

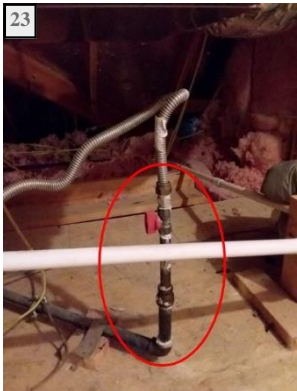
1.		Item	Furnace
		Concern	Drip leg is missing
		Location	Attic
		Impact	Does not provide ideal moisture and debris protection for appliance.
	Suggested Action		Consider having repaired by a licensed plumber
	Other Information		A drip leg is a short vertical section of pipe usually installed near the appliance supply valve, the purpose of which is to catch moisture and debris so as to avoid having it enter the appliance and possibly cause damage or malfunction.

True at both furnace units

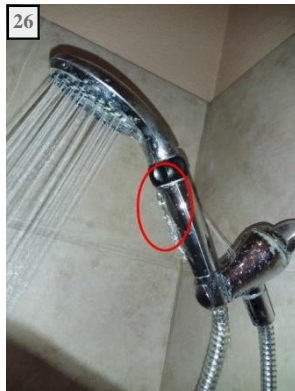
Item	Shower / Tub
Concern	Leak at shower head
Location	Hall Bathroom
Impact	In some instances, may damage surrounding wall or ceiling materials
Suggested Action	Replace or repair handset

Hall Bath

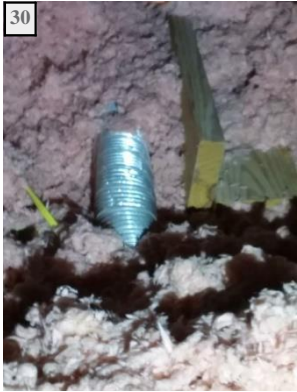
1.					
	Item	Kitchen / Bath Exhaust			
	Concern	Exhaust duct does not vent to exterior of structure			
	Location	Attic			
	Impact	Could allow moisture and/or grease build-up in living areas or attic, possibly resulting in fire hazard			
	Suggested Action	Direct exhaust to exterior of structure through approved ducting and vent hood

True of all room air exhaust vents in bathrooms and laundry room
